**DURABILITY OF PROTECTIVE COATS, FORMED ON BUILDING  
WOODEN PRODUCTS USED IN OUTSIDE IN NESEBAR REGION**

Panayot A. Panayotov, Zhivko V. Georgiev, Nevena Batacheva  
University of Forestry, 1756 Sofia, 10 Kliment Ohridski Bulvard

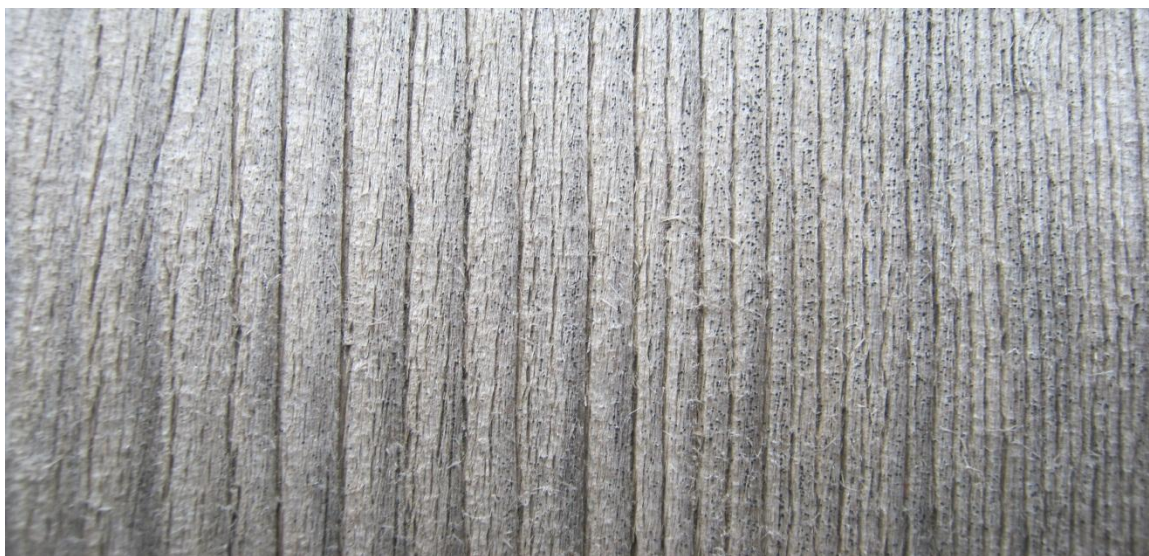
**Figure 1. Appearance of weathered *spruce* wood**

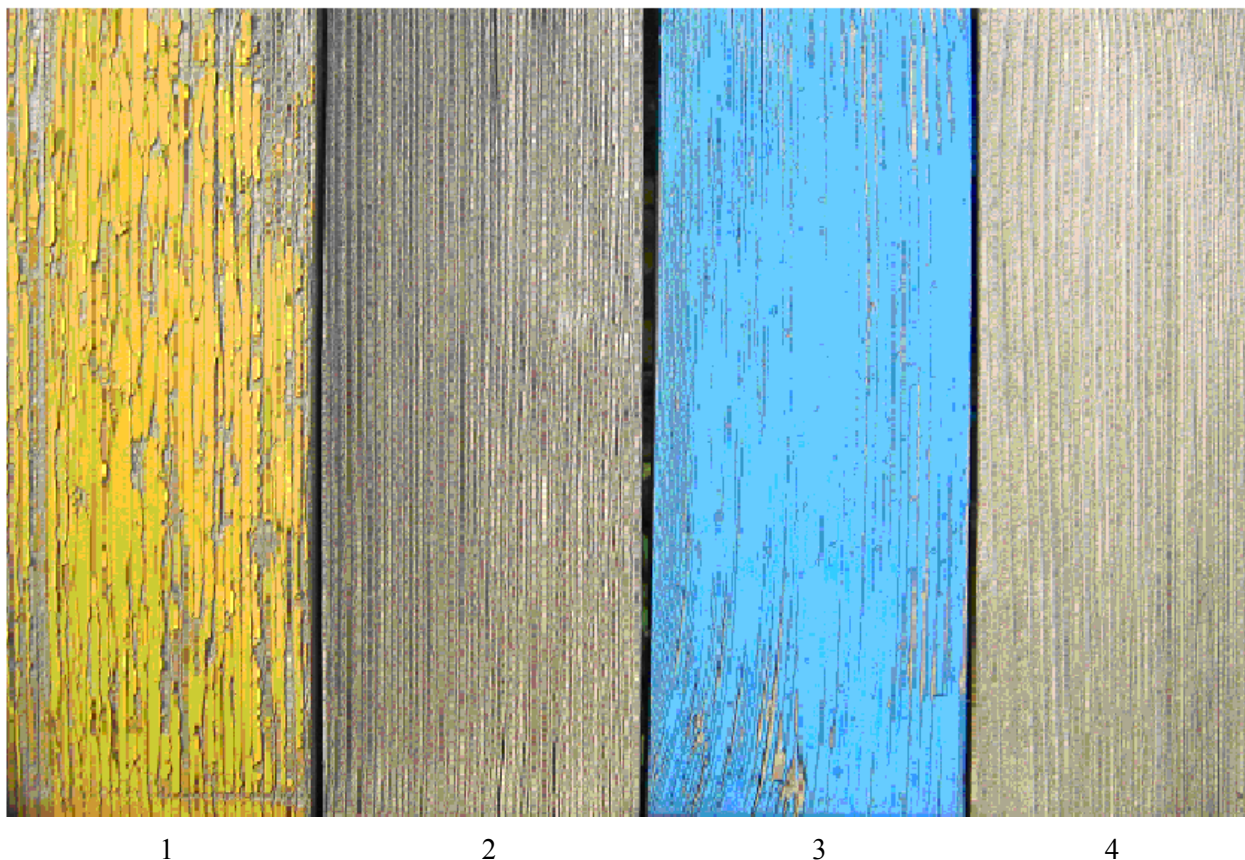
Figure 3 . Spruce etalon samples outdoor exposed for period of 5 years

- 1-left yellow paint NC -11 Lackprom-Sofia; 2. -chlorine rubber lacquer POLD-transparent with light resistance additive- University of forestry- Sofia; 3.- chlorine rubber paint Lackprom-Sofia ;  
4.-mono component alkyd-urethane lacquer with light resistance additives PU-102.

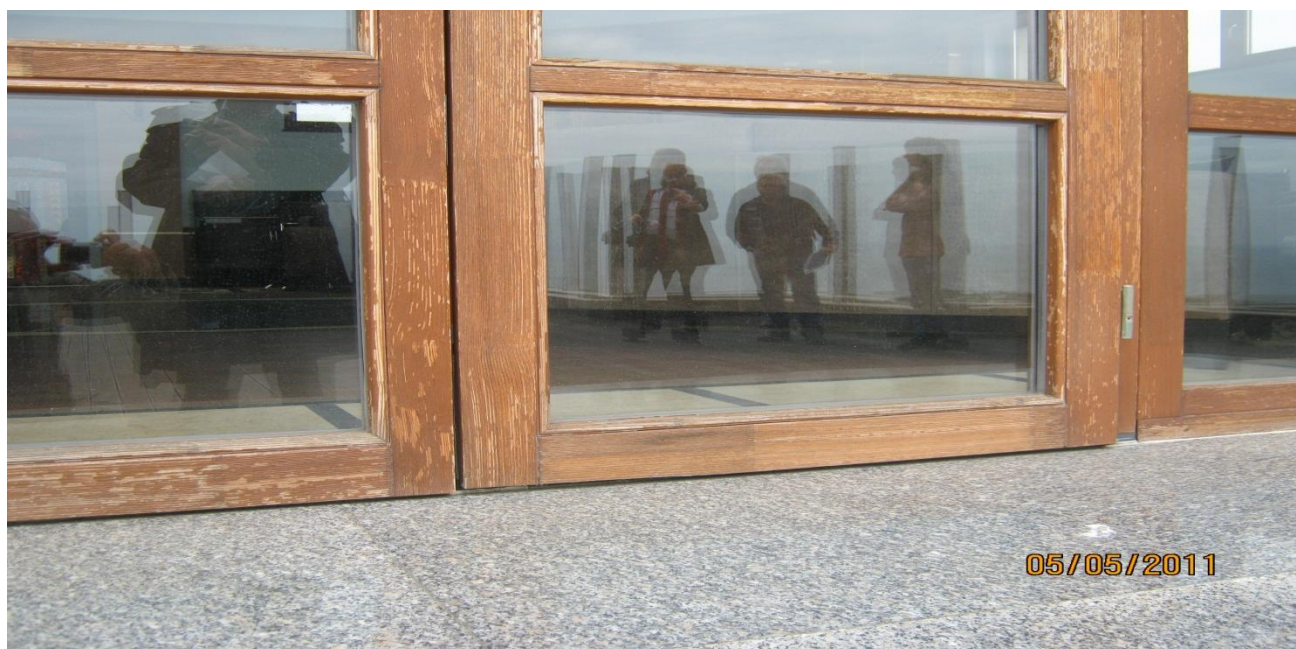
1. Ninth-floor -sky bar with terrace decking flooring teak wood overlooking the sea (south east). Coverage on horizontal and vertical surfaces of the framework friezes doors at the bottom is about 60% detached, the remaining upper protective layer is easily separated into fine flakes appear underneath layers of yellow brown primer. On the horizontal surfaces of the slats fixing glass, the coating is completely stale and gray wood is visible, therefore is impaired adhesion between the wood base and between the primer and topcoat and primer (photos 1, 2, 3 and 4). The coatings formed on rustic balustrade handles are highly damaged: cracks, and loss or stale (photos 5 and 6);

Photo 1 . Appearance of door coating of sky-bar 9-floor

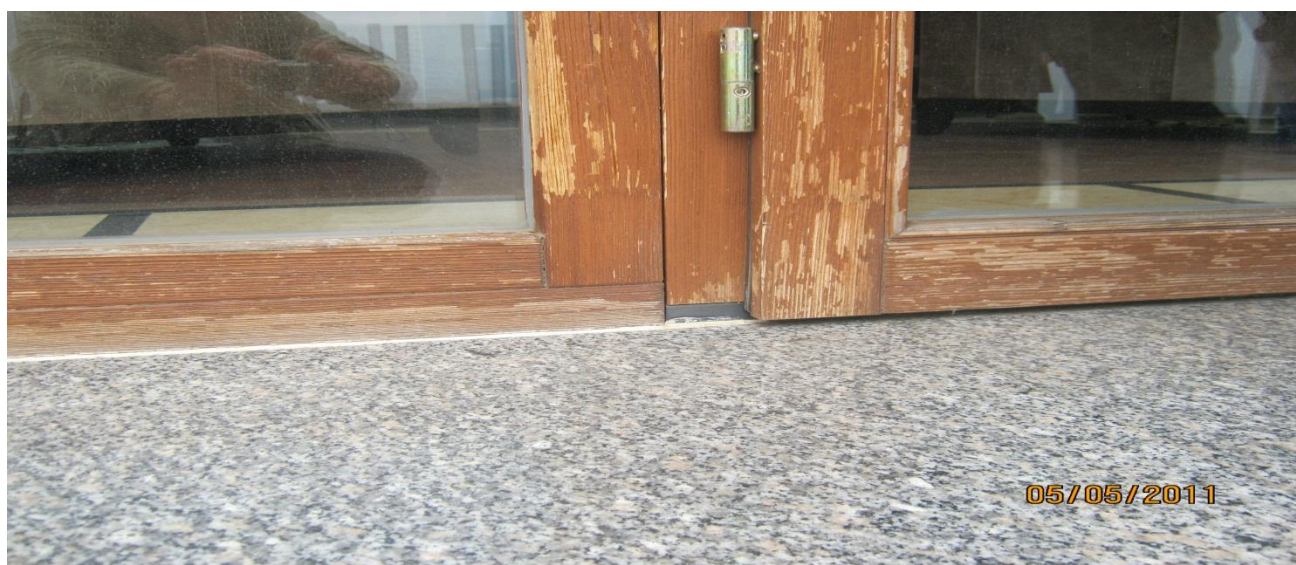
Photo 2 . Appearance of door coating of sky-bar 9-floor

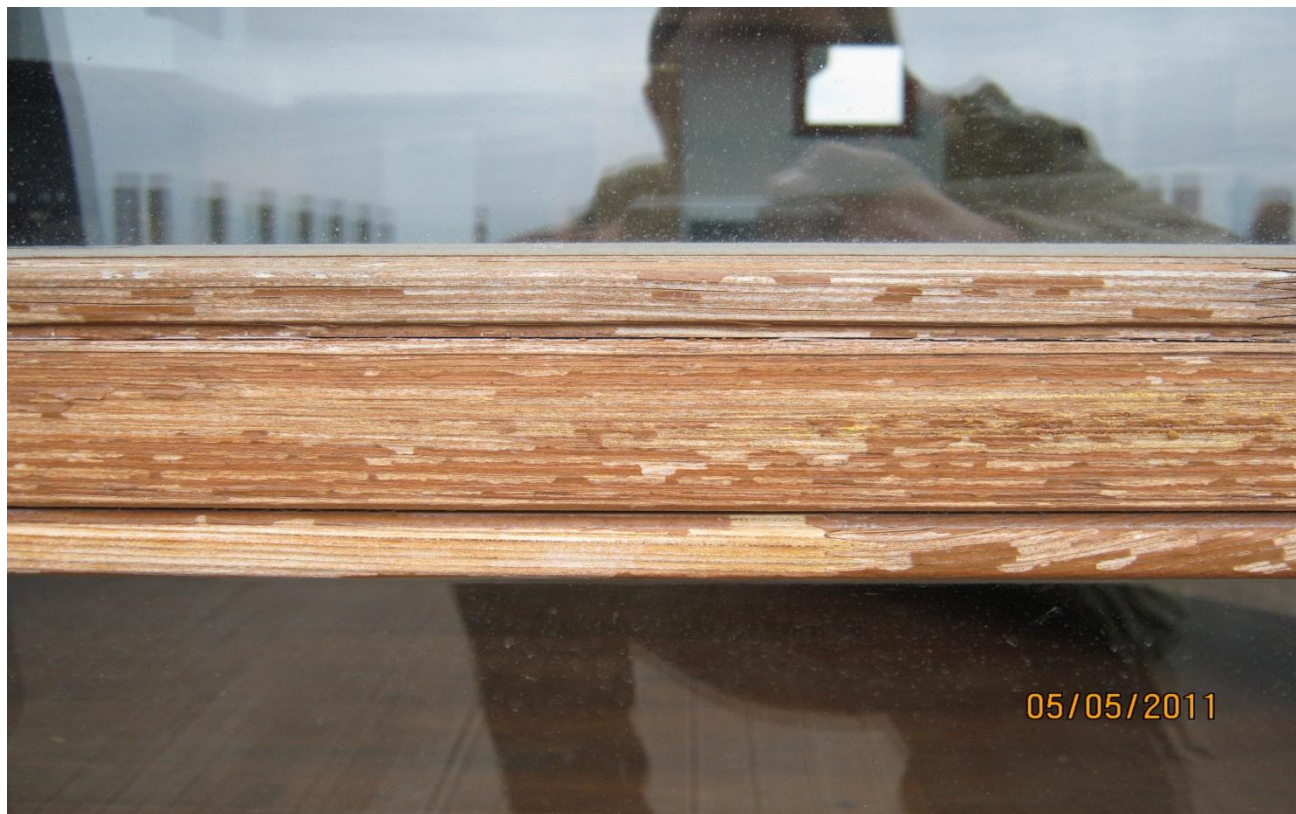
Photo 3. Appearance of coating formed on horizontal door bars of sky-bar 9-floor

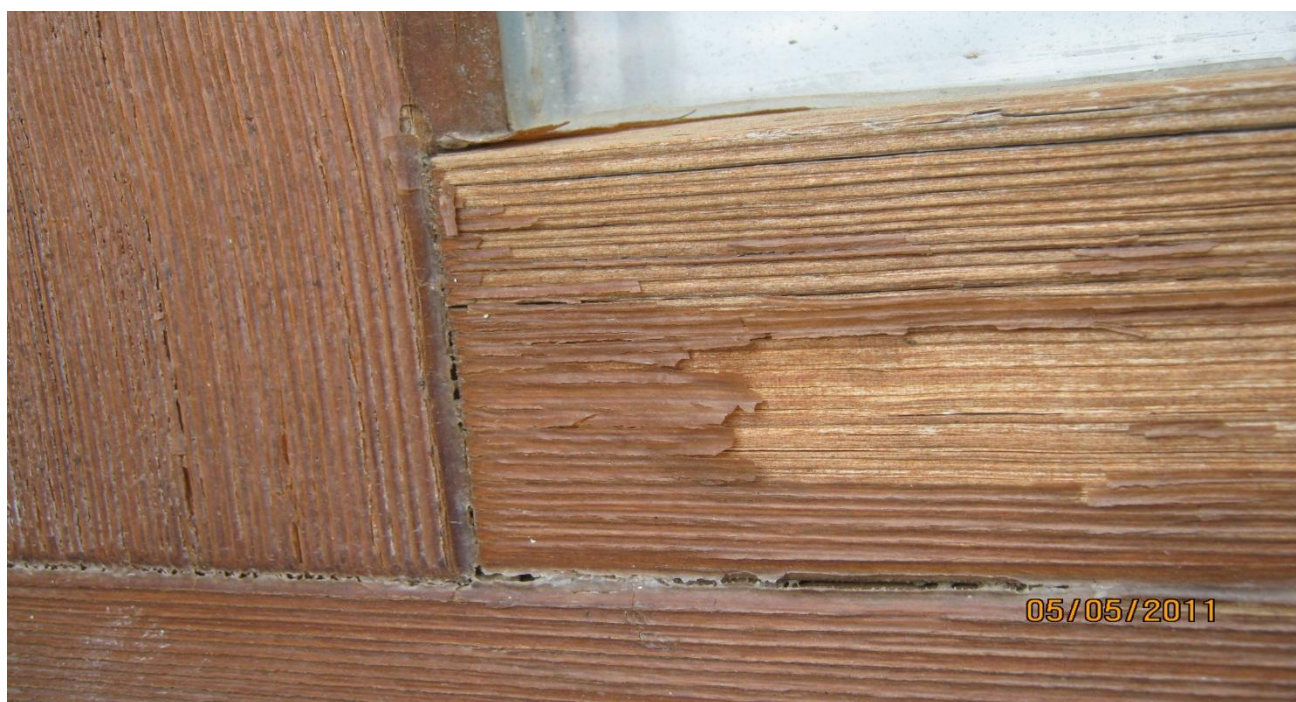
Photo 4. Appearance of coating of horizontal bars of door of sky-bar 9-floor

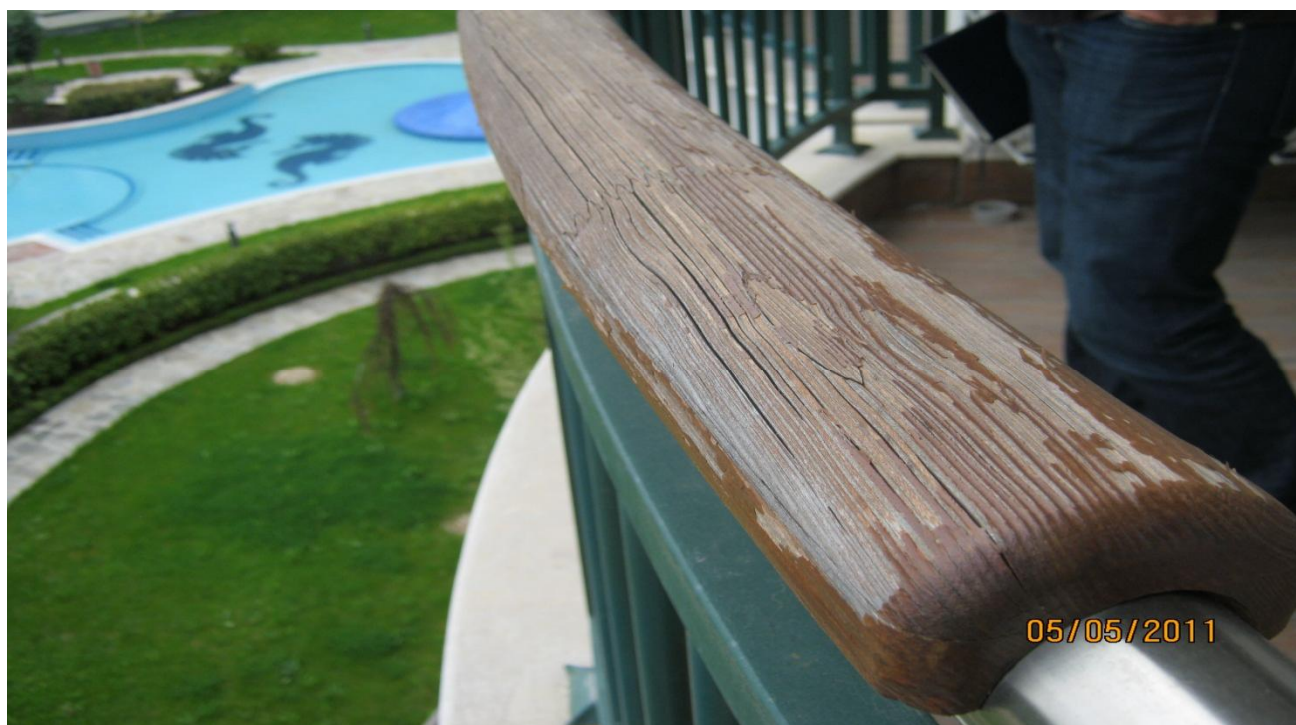
Photo 5 . Appearance of coating formed on rustic parapet handles

3. The coatings formed on the parapet handles are unsuitable. It haven't the necessary elasticity and is very quickly destroyed. This destruction has occurred in the first place of finger-joint, which makes the adhesive film formed with polyvinyl acetate glue class D3. Therefore, in these areas is water, causing swelling and shrinkage of the wood, hence the same is cracked. Balustrade handles are strongly cracked and likely to collapse completely.

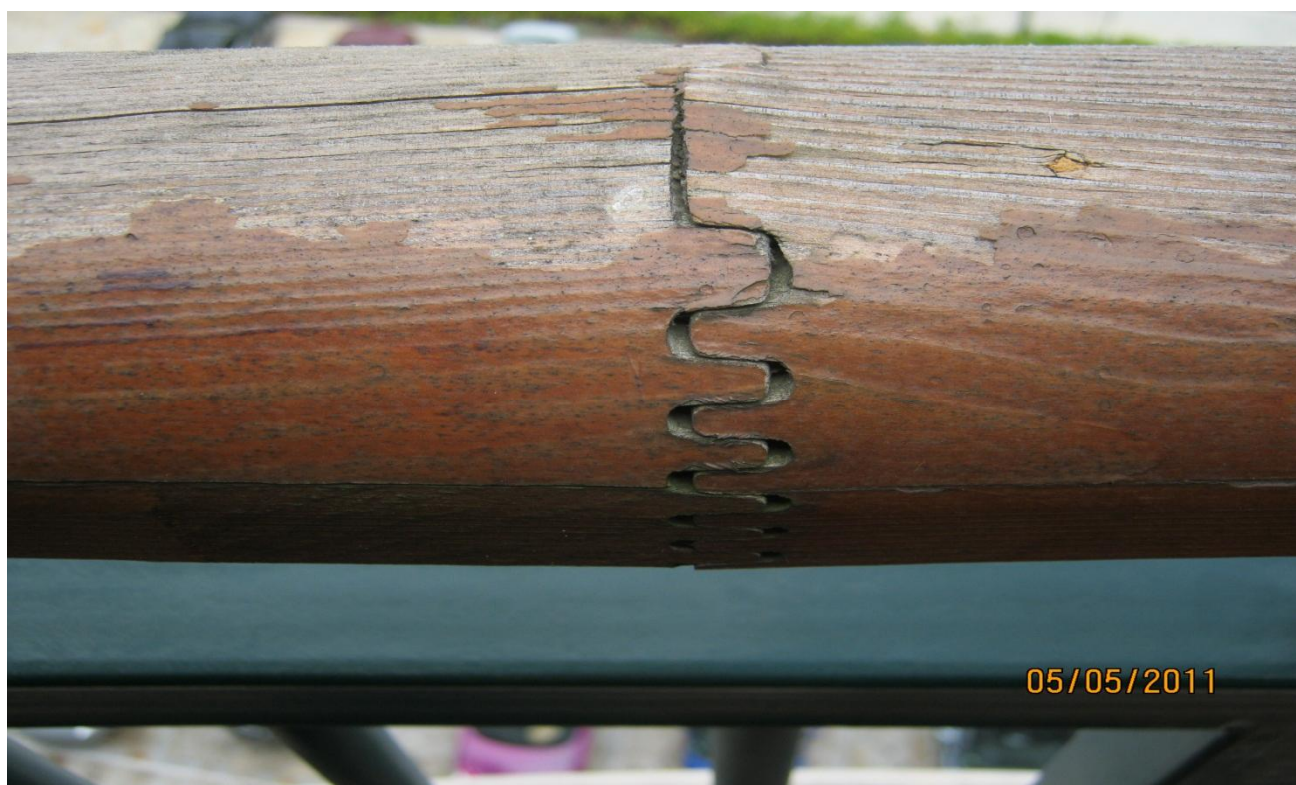
Photo 6. Appearance of coating formed on handle, jointed in length

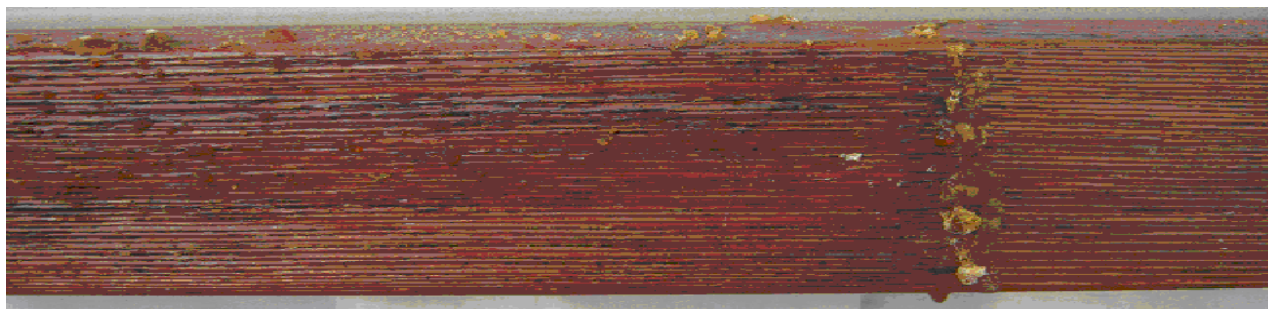
2. Eighth floor (apartment facing north). Coating on the handles parapet top is cracked and partially stale, but relatively preserved by the color red has become darker. Coverage on horizontal and vertical surfaces of the lower friezes is partially destroyed and there slaughtered resin (photo 7);

Photo 7 . Appearance of coating formed on vertical surface with resin exudation

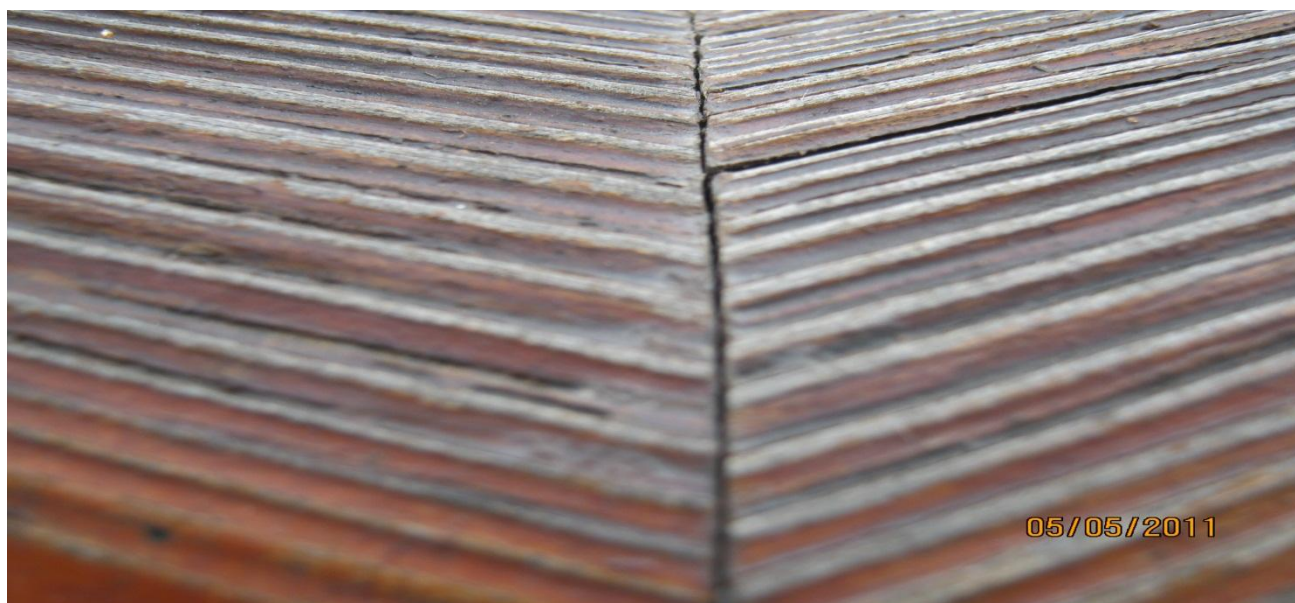
3. Seventh Floor (studio facing northwest). Coating on the parapet above handles 70% stale links and end-arcs are loose. Bare wood areas is partially cracked (Photo 8);

Photo 8 . Appearance of coating formed on the arc handle

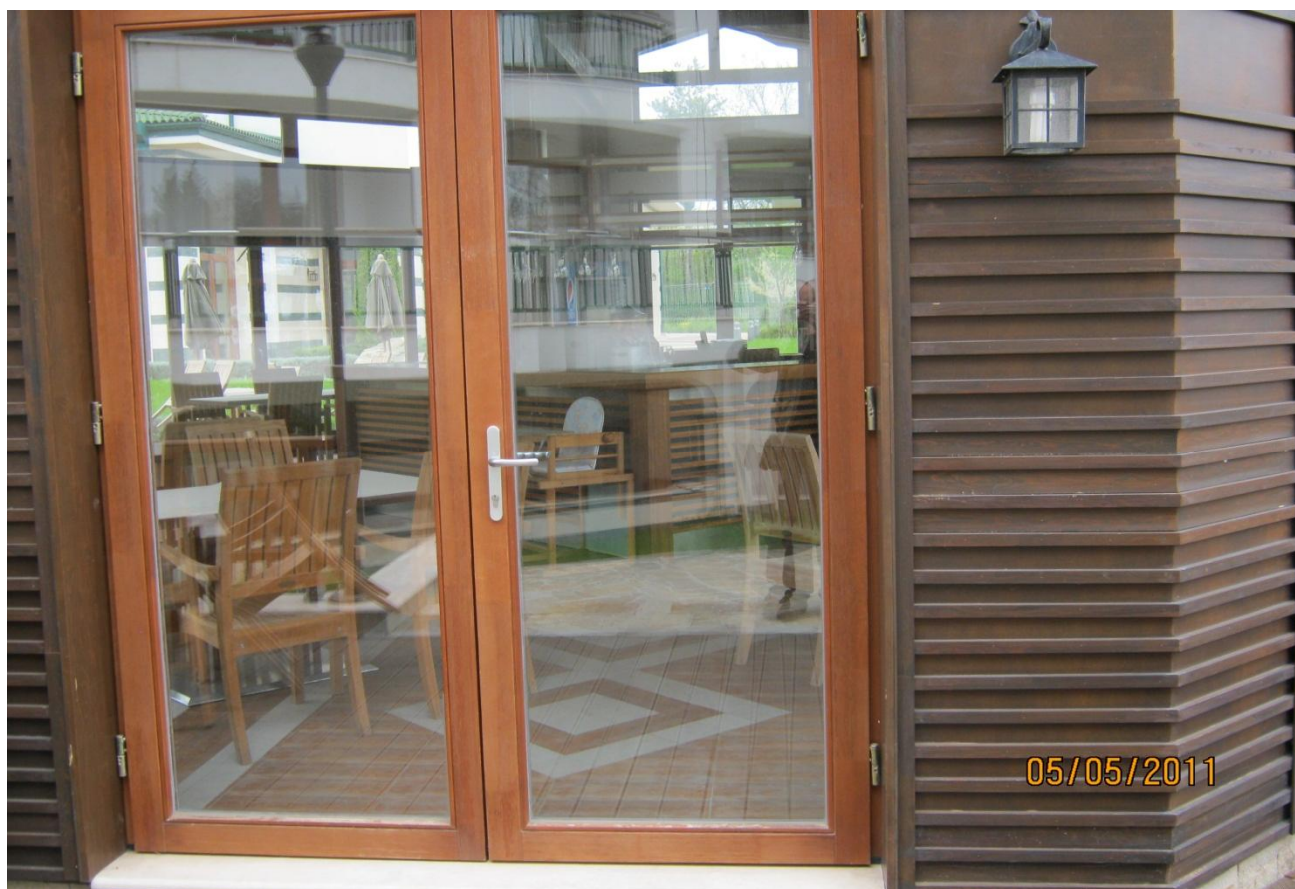
6. Entrance doors - finish with a lighter color with early signs of a fracture of the upper layer and the neighboring wood finishes with a darker brown color are relatively preserved (photo 9), ie the pigment had no effect (the dark pigment is more resistant to solar radiation).

Photo 9. Appearance of coating formed on door bars and siding

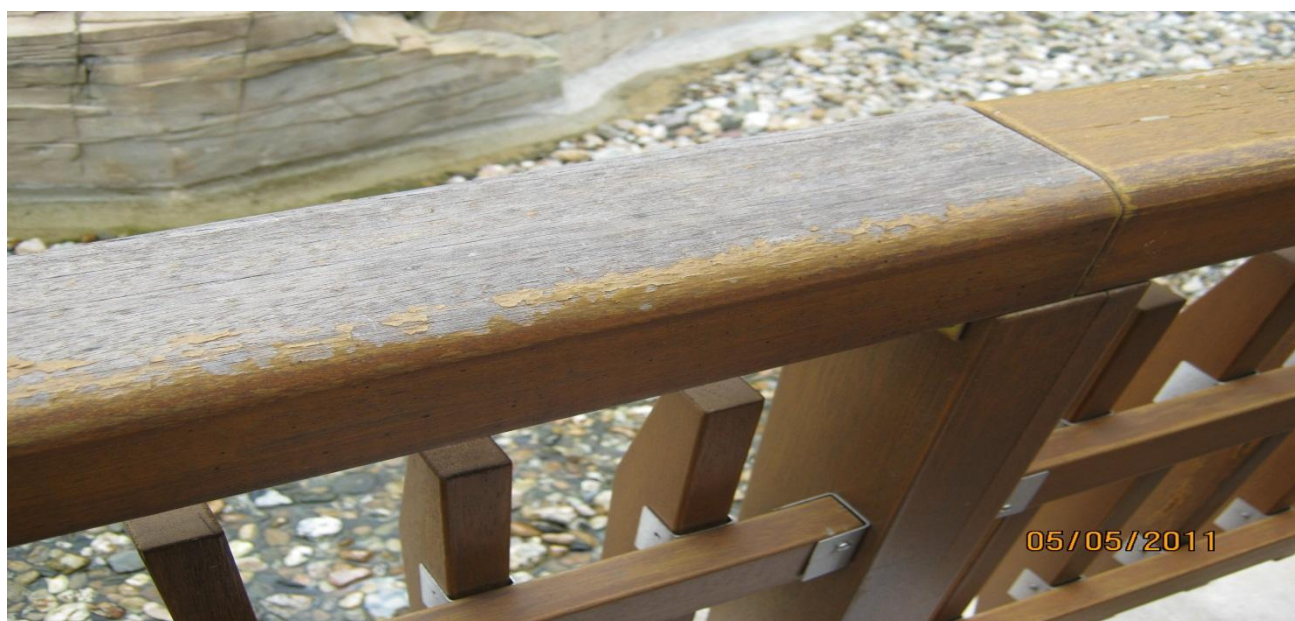
7. External railings made of meranti. Coatings on the horizontal surfaces of the balustrade handles are partially destroyed (Photo 10);
8. Structural elements of woodwork made from finger jointed lamellas glued triple-Pine wood are in very good condition. Profiles are skewed to 180, allowing rainwater to drain quickly. The edges are rounded (rounded to within 4 mm), which ensures continuity of coverage. The windows are fully hydro with silicone, which prevents ingress of rainwater. Sustains external battens are tight fitting.

Photo 10. Appearance of coatings formed on parapet handle horizontal surfaces, made of meranti
