RADIATION INCIDENT IN “POLIMERI” DEVNYA, ACTIONS AND SAFETY MEASURES: A CASE STUDY

Key words: radiation, incident, safety, measures

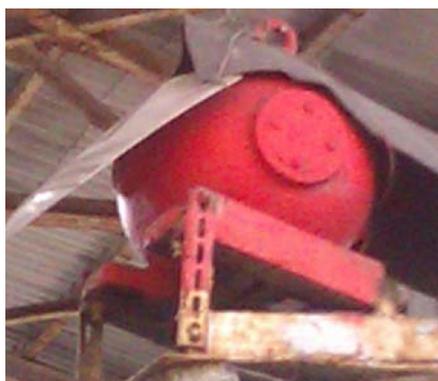
Figure 3. Level gauge in the workshop "Liquefaction" - Polimeri AD, Devnya

The overall appearance of the sources as part of the stolen level switches is shown in Figure 3. The photograph shows the source of the level gauge, placed in a tank in the workshop Liquefaction. The stolen sources and the shown source in the photograph are identical. The only difference is the layout of the emitter and the detector. The stolen sources were placed on one level with the detector on both sides of the tank. The source in the photograph is mounted on top of the tank and the detector is mounted on the bottom part of the tank.

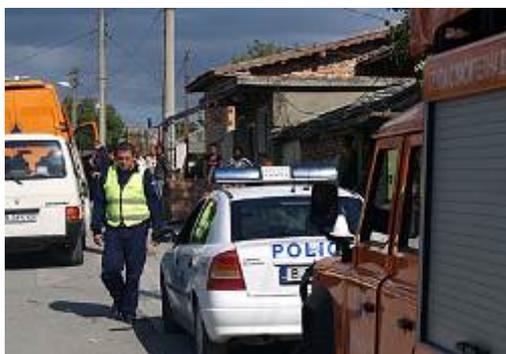
Figure 4. Preslav Street, Residential area Gabena Mahala, town of Devnya at the time of removal of the radioactive material

The other two members of the team of the Regional Health Inspection Varna together with the representatives of the police, the Fire Department, the Municipality of Devnya and Polimeri AD went to the Roma residential area. The author of this paper measured safe values of dose rate of the radioactive background. This area was marked with signaling band. Lots of houses of the inhabitants of the residential area are situated there. By the help of the police department the inhabitants were evacuated from the zone of danger (Figure 4).

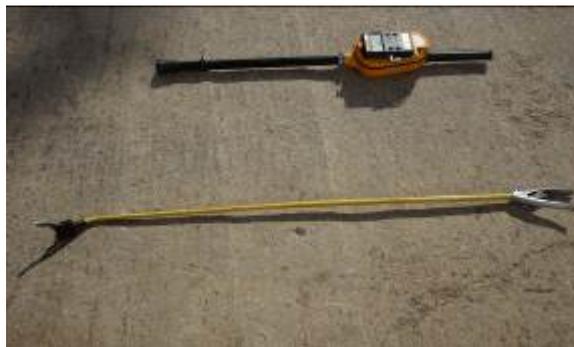
Figure 6. Radiation measuring device (on the top of the photograph). Clamp for handling of radioactive sources (on the bottom of the photograph)

The specialists of Multitest OOD and the Fire Department found the stolen sources and took them out of the residential area. For the whole operation, the equipment owned by Multitest OOD was used (Figures from 5 to 9).

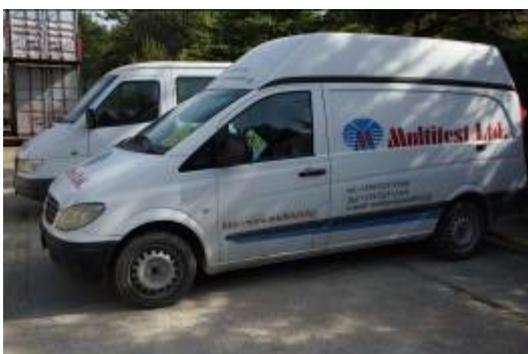
Figure 7. Vehicle of Multitest OOD

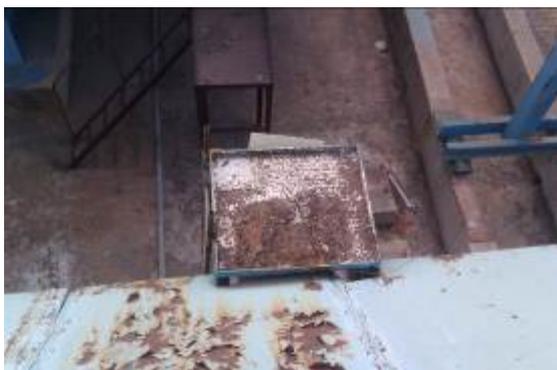
Figure 10. Site where the radioactive source was mounted (seen from above)

The next step was to perform a full inspection on the places where the radioactive sources were stolen from (Figures 10, 11).

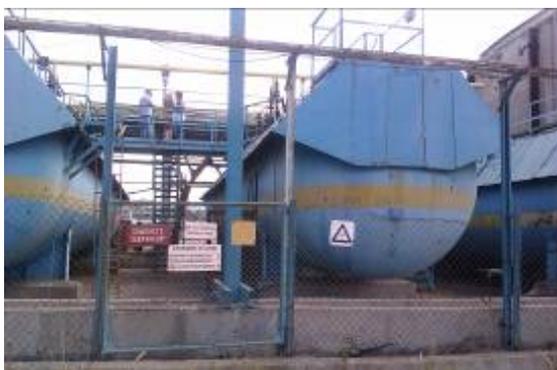
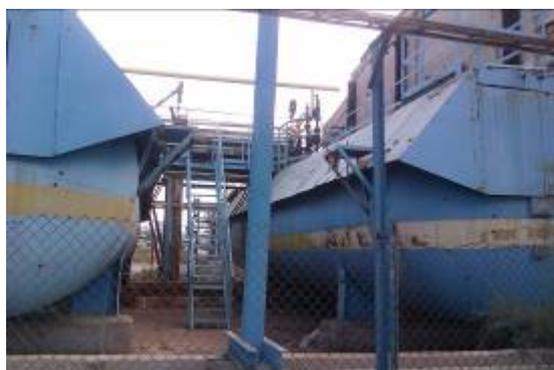
Figure 12. Front side of the fence in the workshop Chlorine and Chlorine Products

During the inspection in the workshop "Chlorine and chlorine products" where the radioactive sources were stolen from, following was found: The tanks with the mounted radioactive sources were surrounded by a fence which was not intact and easy to overcome (Figures 12 and 13). The required labels and signaling were existing. There was a signaling equipment mounted over the level of the radioactive sources. Due to this reason, it was not triggered during the theft. Two of the tanks where the stolen devices have been mounted, were empty at the moment of the theft. Therefore, the radioactive beam from their sources has been stopped. Some quantity of the stored liquid was found in the third tank. For this reason, the radioactive source in this tank was still emitting.

After the inspection, due to the existing risk of a new theft, the Nuclear Regulatory Agency decided to revoke the license of the company Polimeri AD. An order was issued for dismantling of all 8 radioactive sources on the territory of the company.

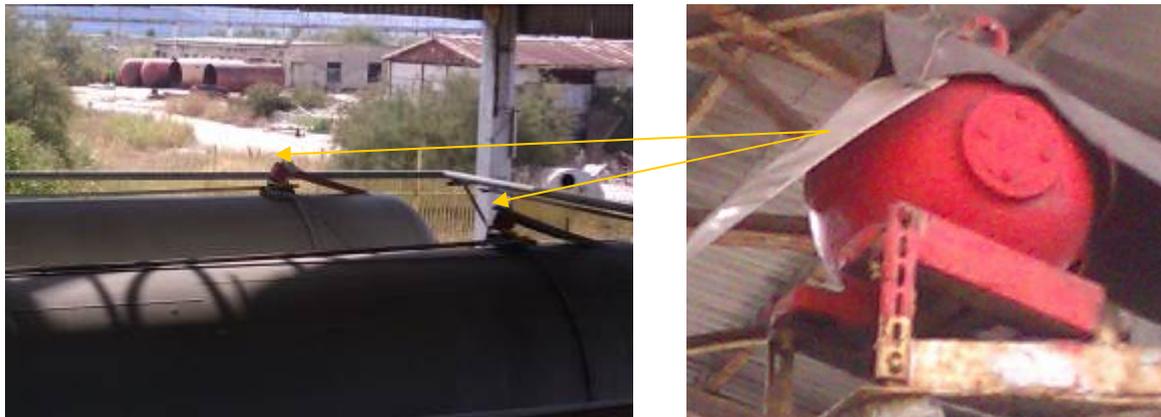
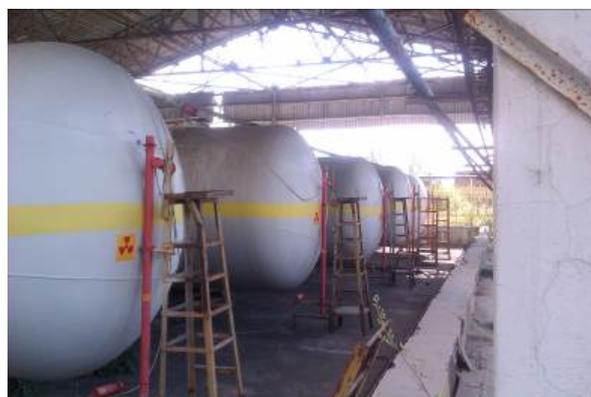
Figure 14a. Tanks with level gauges in the workshop "Liquefaction" - the emitters

The inspection in the workshop “Liquefaction” (Figures 14a, 14b) found 5 functioning level gauges, mounted on 5 tanks. They were in compliance with the requirements of the radiation protection. The inspection in the workshop Purified Caustic Soda (Figure 15) established the existence of 3 level switches, mounted on two tanks.

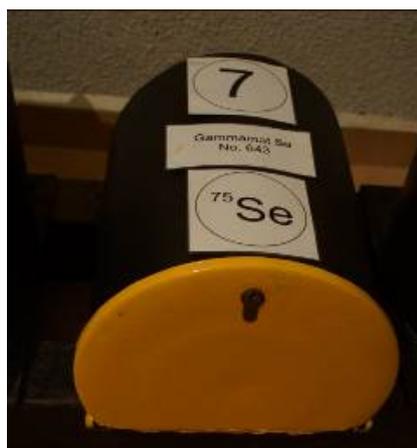
Figure 16. Sample of a container, where the found radioactive sources were placed for temporary storage

In accordance with the safety prescription for temporary storage of radioactive waste at Polimeri AD the container for the found radioactive sources was exchanged (Figure 16). This exchange was realized by the company Multitest OOD. The exchange was done within 3 minutes. All actions were performed under dosimetric control. High momentary doses of about $500\mu\text{Sv/h}$ were measured. After completion of the operation, again under dosimetric control was performed. It was found that the values comply with the radiation protection.
